Software and Radio Frequency Card Upgrade Instructions

Alaris® PC Unit, Models 8000 and 8015
Upgrade to v9.5.x and IEEE 802.11a/b/g

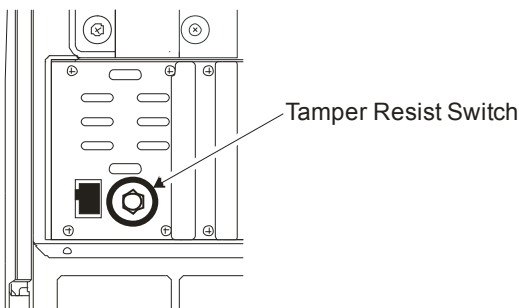
- While holding down tamper resist switch on back of PC Unit, press **SYSTEM ON** key.

PC Unit (partial view of back)

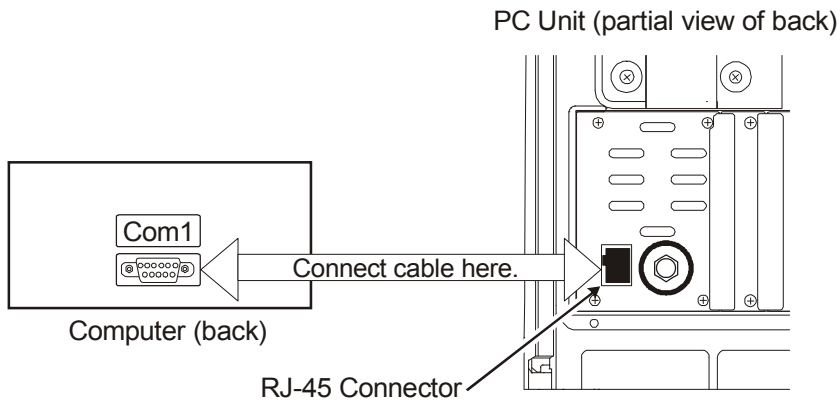
1. Plug PC Unit into AC power.
2. Verify software version needs to be upgraded (see "Identify Software Version," page 3).
3. Remove rubber plug from RJ-45 connector on PC Unit.
4. Connect serial cable between RJ-45 connector and Com port on personal computer.

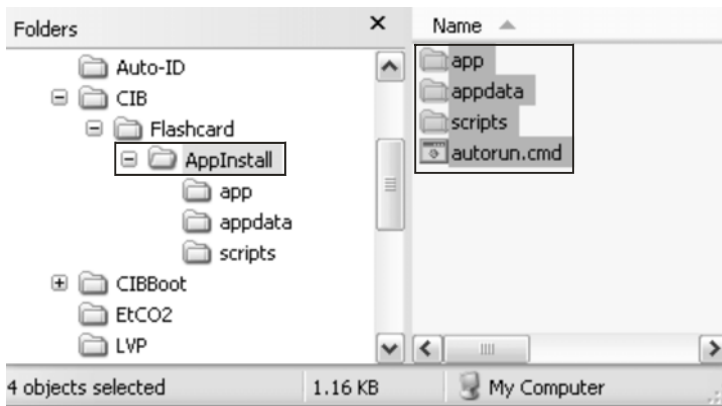
1. Label one FAT16-formatted CF card as "8000 App."
2. Connect CF card reader to computer.
3. Insert CF card labeled "8000 App" into CF card reader and delete any existing contents on card.
4. Using Windows Explorer, locate **AppInstall** folder on v9.5.x Point-of-Care Software CD (path: **\CIB\Flashcard\AppInstall**).
5. Copy **AppInstall** folder contents (not folder itself) to CF card. When complete, CF card should contain three folders and **autorun.cmd** file.

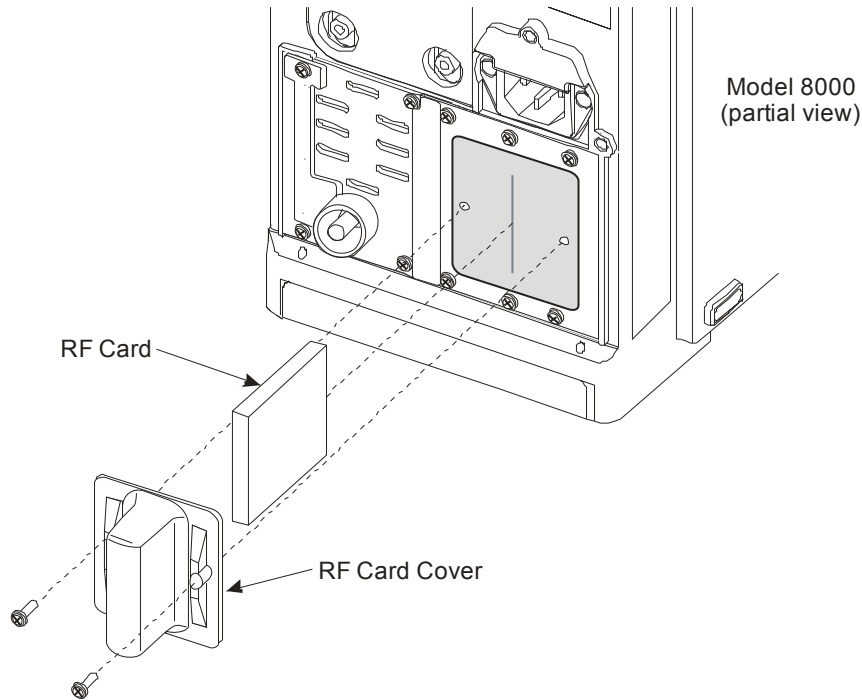
6. Remove RF card cover.
 - If RF card is being upgraded to an IEEE 802.11a/b/g RF card, retain RF card cover for possible future use. Retain screws for use when installing new cover.

- If RF card is not being upgraded, retain RF card cover and screws for use when reinstalling cover.

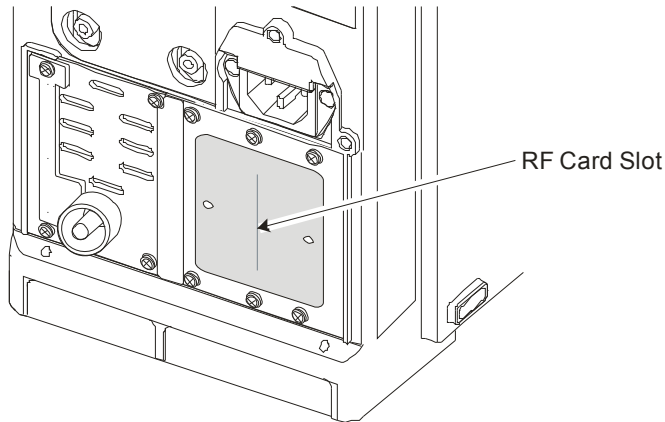
8. Insert CF card labeled "8000 App" into RF card slot.

The CF card can be inserted in only one direction—with label facing the center of the PC Unit. To avoid damaging the pins, do not force the CF card into the connector or to the left.

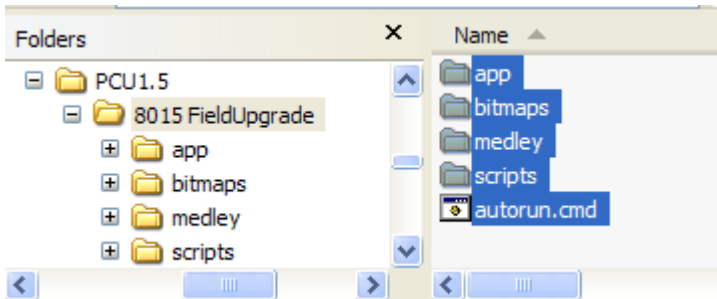
- Using Windows Explorer, locate **8015 FieldUpgrade** folder (path: **\PCU1.5\8015 FieldUpgrade**).
- Copy contents of **8015 FieldUpgrade** folder (not folder itself) to CF card labeled “8015 App.” When complete, CF card should contain four folders and an **autorun.cmd** file.

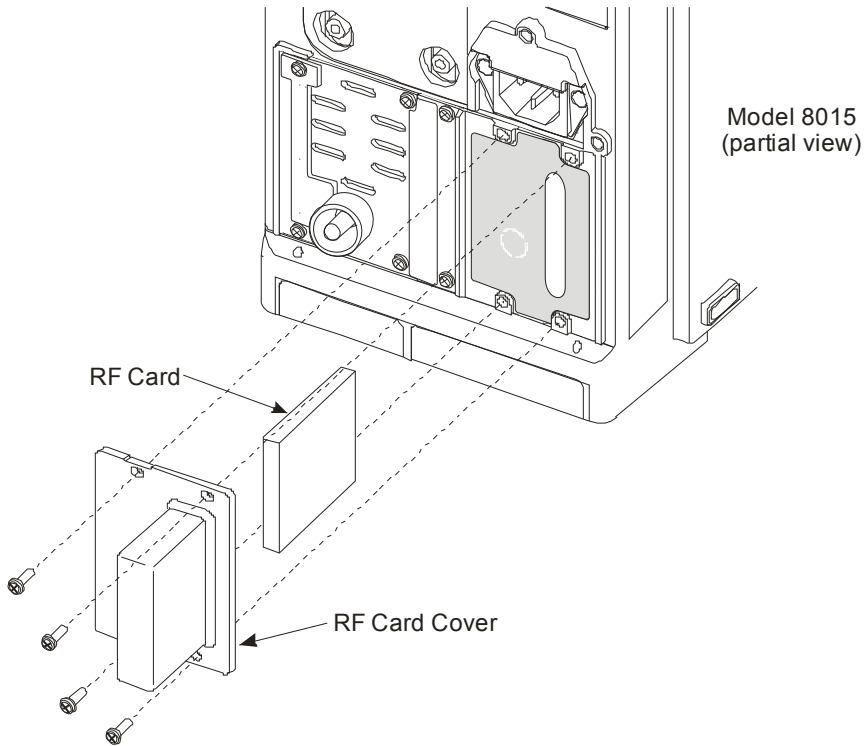
- Remove CF card labeled “8015 App” from CF card reader.
- Ensure that PC Unit is powered off and not plugged into AC power.
- Remove RF card cover.
 - If RF card is being upgraded to an IEEE 802.11a/b/g RF card, retain RF card cover for possible future use. Retain screws for use when installing new cover.

- If RF card is not being upgraded, retain RF card cover and screws for use when reinstalling cover.

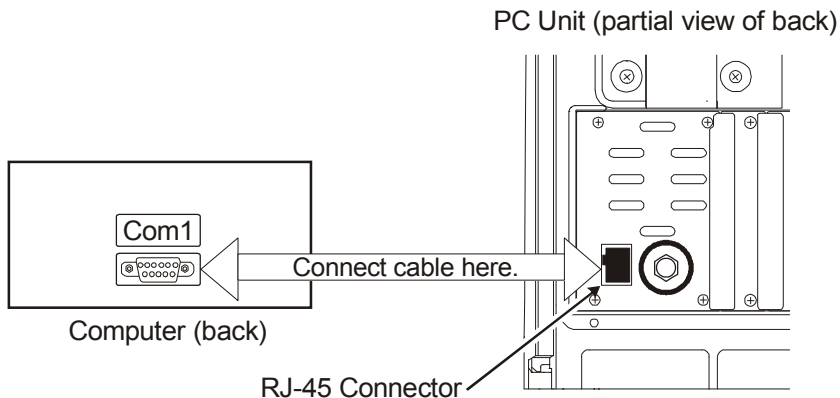
1. Plug PC Unit into AC power.
2. Verify that PC Unit is successfully upgraded (see "Identify Software Version," page 3).
3. Remove rubber plug from RJ-45 connector on PC Unit.
4. Connect serial cable between RJ-45 connector and Com port on personal computer.

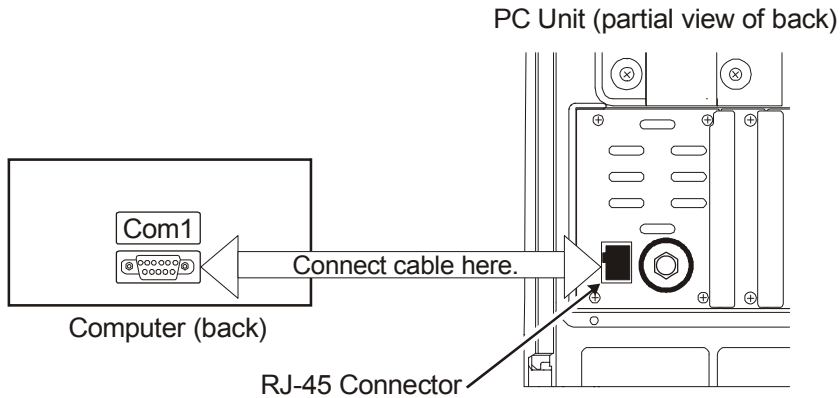
4. Connect serial cable between computer and PC Unit.

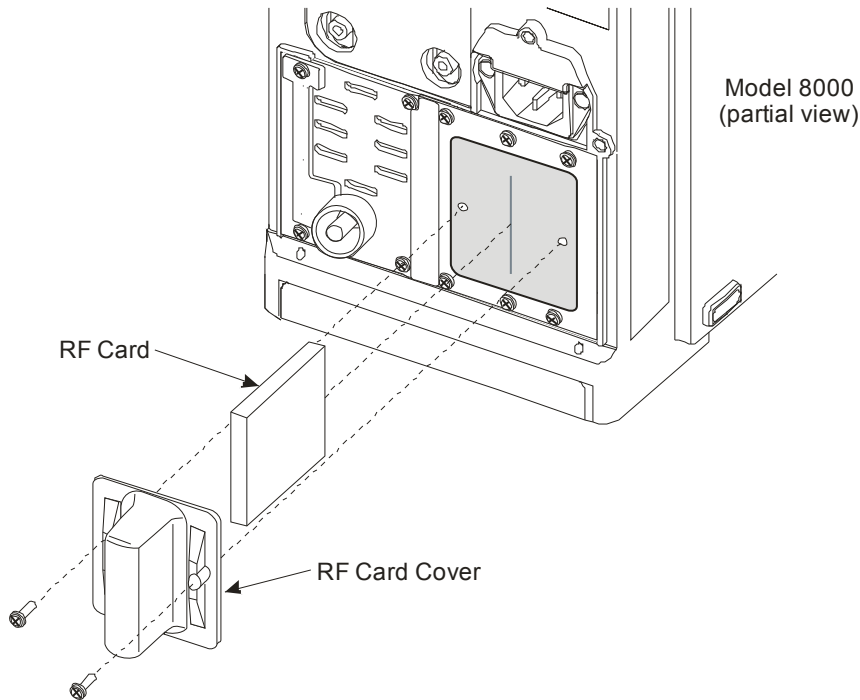
Model 8000:

1. Identify software version to determine if it needs to be upgraded (see "Identify Software Version," page 3).
 - If PC Unit software is not v9.5.x or later, perform applicable software upgrade and then continue with this upgrade, beginning at step 7 (see "Model 8000 Software Upgrade," page 6, or "Model 8015 Software Upgrade," page 12).
 - If PC Unit software is v9.5.x or later, continue with next step.
2. Power off PC Unit.
3. Remove RF card cover.
 - Retain screws for use when installing new cover.
 - Retain RF card cover for possible future use.

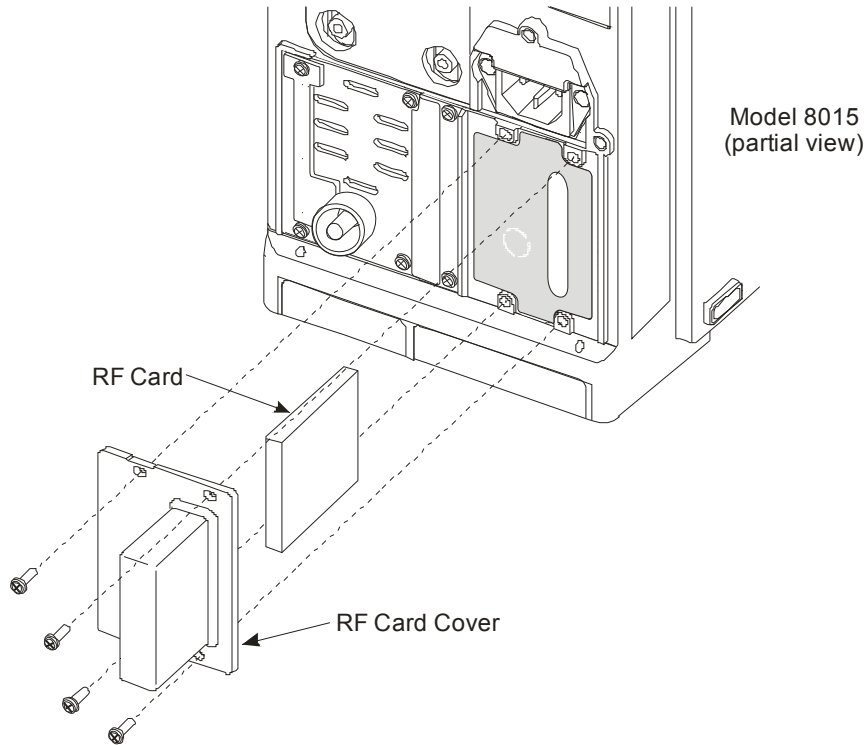
4. Remove RF card and retain for possible future use.
5. Insert IEEE 802.11a/b/g RF card (provided in upgrade kit) into RF card slot.
 - Model 8000: Insert card with LED facing center of PC Unit.
 - Model 8015: Insert card with LED facing away from center of PC Unit.
6. Install RF card cover (provided in upgrade kit).
